EVALUATION OF A RED-SILICONE-COATED VISUAL APPROACH SLOPE INDICATOR (VASI) LENS

NATIONAL AVIATION FACILITIES EXPERIMENTAL CENTER ATLANTIC CITY, NEW JERSEY

JANUARY 1977

FINAL REPORT

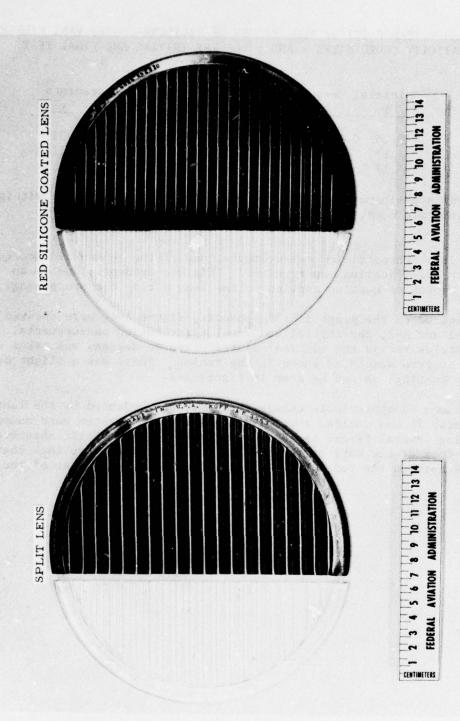
76-31-1

Figure 1 is a photograph exhibiting both the split lens assembly shown on the left and the coated lens shown on the right. It can be seen in the photograph that the red segment is somewhat larger than the clear. When installed in the

COMPARISON BETWEEN SPLIT LENS ASSEMBLY AND RED-SILICONE-COATED LENS FIGURE 1.

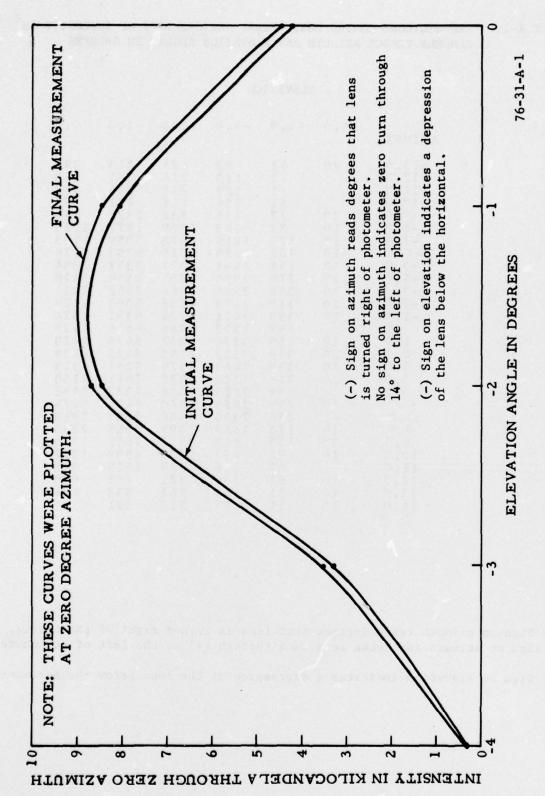
The curves plotted on the graph in the appendix, figure A-1, were derived from the tables A-1 and A-2, the initial and final distribution measurements. The output in candelas versus the vertical distribution in degrees was taken at the midpoint or zero azmuth as shown in the tables. There was a slight degradation of the coating, as can be seen in figure A-1.

VERTICAL DISTRIBUTION CURVE AT ZERO DEGREES AZIMUTH FOR INITIAL AND FINAL TESTS FIGURE A-1.
